**Flood Control Project Maintenance
Levee Inspections**

Fall 2018 Levee Maintenance Deficiency Summary Report

Sacramento River Basin

Reclamation District No. 0010 Honcut

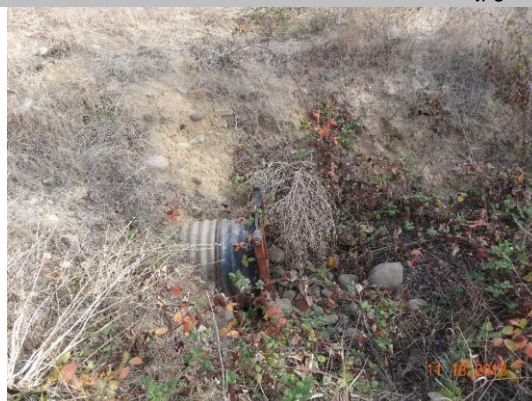
Photo 3 of 3 : UCIP_FA_2018_27791_51504.jpg

View of pipe and flap gate located on waterward side.

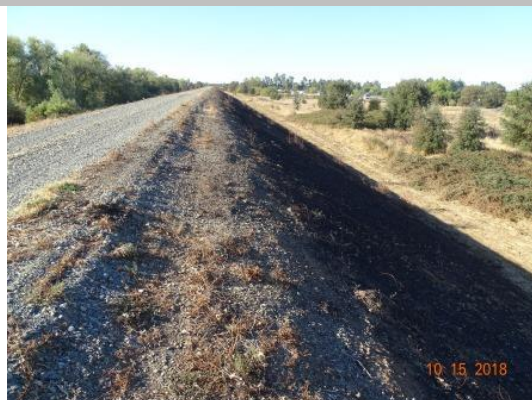
Photo 1 of 1 : FA_2018_RD0010_163_27_20181108_00091.jpg

LM Start	0.02	Rating **	A	Issue No.	27
LM End	7.64	Issue Type +	Ma	Location *	LS
Category	Earthen Levee			GPS Latitude/Longitude	
				Start	End
Item	Vegetation			39.163680 °	39.256061 °
				-121.609574 °	-121.574942 °
DWR ID	DWR_RD0010_01_f_2018_27				
Comment Code					
V1 : Control annual grass and weeds on the levee slopes and easements.					
Inspector Comment					
The annual vegetation is well maintained, Fall 2018.

View looking downstream landside of the well maintained vegetation, Fall 2018.

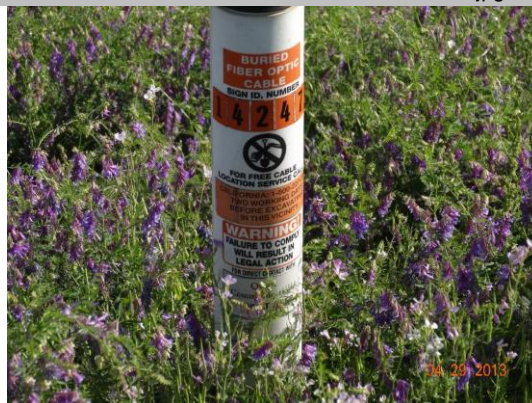
Photo 1 of 2 : UCIP_FA_2018_27712_51365.jpg

LM Start	0.23	Rating **	M	Issue No.	67
LM End	0.23	Issue Type +	En	Location *	
Category	Supplemental			GPS Latitude/Longitude	
				Start	End
Item	DWR UCIP Field Study			39.163407 °	39.163407 °
				-121.605645 °	-121.605645 °
DWR ID	24653				
Comment Code					
Inspector Comment					
FS_ID:27712					
DS_ID:24653					
EP_NO: N/A					
Repair Type: Non-Urgent					
Crossing Status: Indicator Found					
UCIP Comments: 04/29/2013 Need to contact owner--unable to determine if crossing is authorized (no permit found) also need to determine if crossing goes through levee. (DWR UCIP - O. Magana)					
FIELD_STRUCT_DESC: Fiber optics line markers on the levee slope.					
Unable to determine if this line goes through the levee. This line was field discovered.					
FS Date: 4/29/2013

Contact information for buried fiber optic cable.

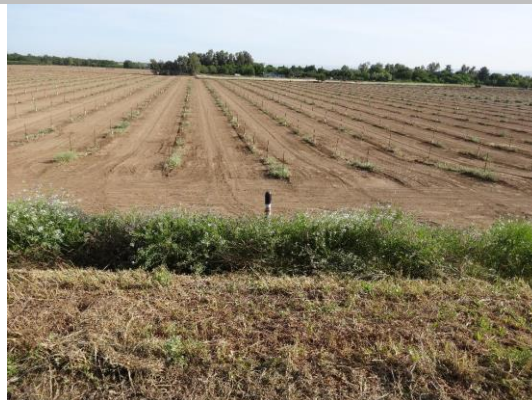
Photo 2 of 2 : UCIP_FA_2018_27712_51364.jpg

Marker visible on landward side.

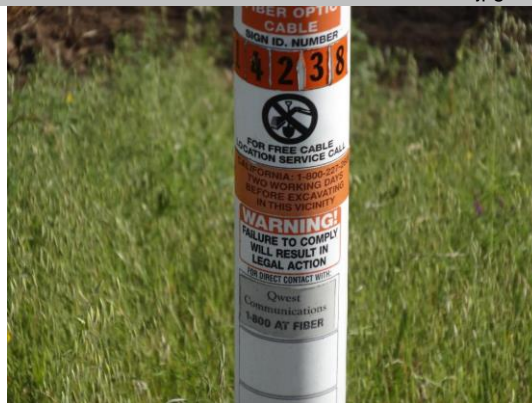
Photo 2 of 2 : UCIP_FA_2018_27713_51367.jpg

Contact information for communication line.

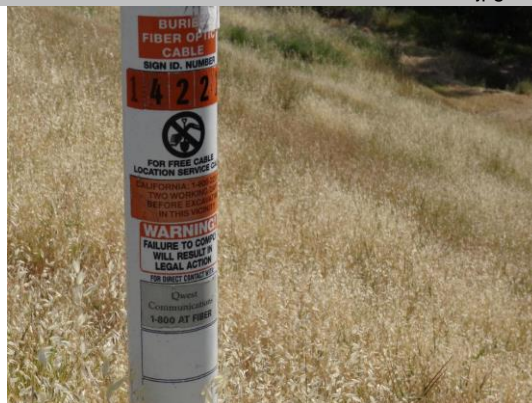
Photo 2 of 2 : UCIP_FA_2018_27715_51370.jpg

Contact information and ID number for buried fiber optic cable.

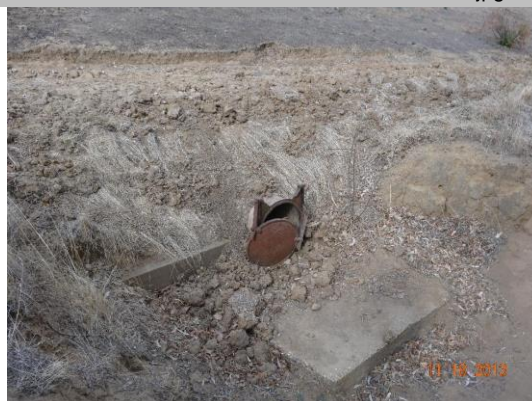
Photo 3 of 3 : UCIP_FA_2018_50058_51414.jpg

FS_ID:50058
DS_ID:21258
EP_NO: N/A
Repair Type: Non-Urgent
Crossing Status: Found
UCIP Comments: 7/01/2016 Gate has been repaired--WS gate is functional. LS gate still needs new stem for the gate to properly function--stem is bent. USACE's PI issue references permit number 13710 this is incorrect permit is associated with DS_ID 21259 (CLM 0.767). (DWR UCIP - omagana)4/29/2013 Damaged flap gate on waterward side and damaged stem on screw gate on landward side. Need to contact owner to determine if crossing is still active. If crossing is still in use owner will need to address damage on flap gate and screw gate. If crossing is no longer in use owner will need to contact the CVFPB to comply with Title 23. This crossing is referenced in the USACE Periodic Inspection as item USACE_CESPK_HON1_2013_p_0053 and 0057. (DWR UCIP - omagana)
FIELD_STRUCT_DESC: 24-inch corrugated metal gravity drainage pipe through the levee, 31 feet below the crown. Two corrugated metal cutoff walls around pipe. Concrete headwall at each end. Flap gate on the waterside (WS) end. Slide gate on the landside (LS) end. Pipe discharges into 6-foot concrete splash apron on the WS. [Additional Reference(s): DWR Levee Log, 2005. USACE Sacramento O&M Manual 151, May 1953, (Station 46+60)].

Damage flap gate located on WS.

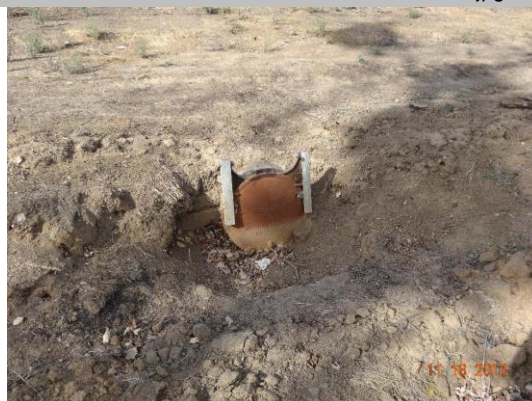
Photo 3 of 3 : UCIP_FA_2018_27748_51451.jpg

View of flap gate located on waterward side.

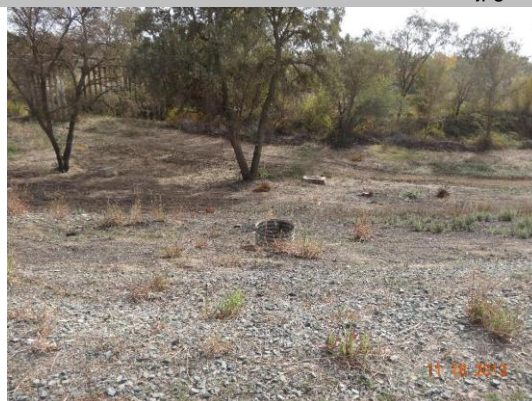
Photo 3 of 3 : UCIP_FA_2018_27725_51384.jpg

View of waterward side-slopes cleared.

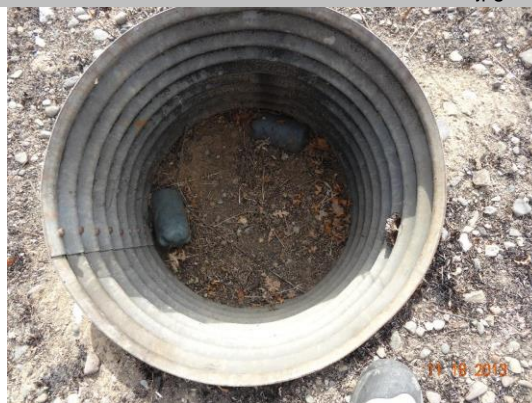
Photo 3 of 3 : UCIP_FA_2018_24810_44575.jpg

Comment Code						
Inspector Comment						
FS_ID:24810 DS_ID:21263 EP_NO: N/A Repair Type: Non-Urgent Crossing Status: Found UCIP Comments: 04/29/2013 Pipe has been capped on waterward side--see photos. Need to coordinate with DWR Inspector to determine whether crossing is compliant with Title 23. This crossing is referenced in the USACE Periodic Inspection as item USACE_CESPK_HON1_2013_p_0016. (DWR UCIP - O. Magana) FIELD_STRUCT_DESC: 10-inch steel irrigation discharge pipe through the levee, 6.8 feet below the crown. Steel cutoff plate around the pipe at the center of the levee. Siphon breaker in corrugated metal pipe (CMP) riser on the waterside (WS) slope. Pump on a concrete base on the WS berm, not present. 36-inch concrete standpipe at the landside (LS) toe. Metal shed and service pole on the WS slope, not present. [Additional Reference(s): DWR Levee Log, 2005. USACE Sacramento O&M Manual 151, May 1953, (Station 14+16)]. FS Date: 4/29/2013

Siphon breaker has been buried inside CMP riser.

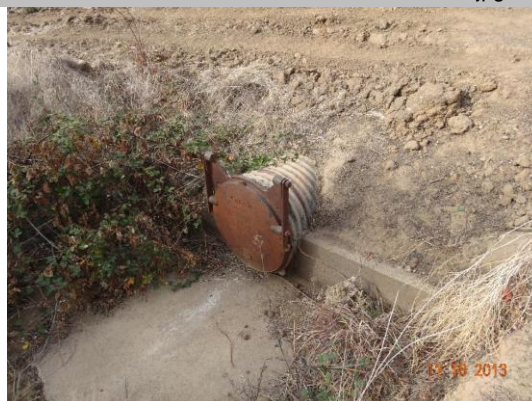
Photo 2 of 3 : UCIP_FA_2018_53136_44587.jpg

View of headwall, pipe, and flap gate located on WS.

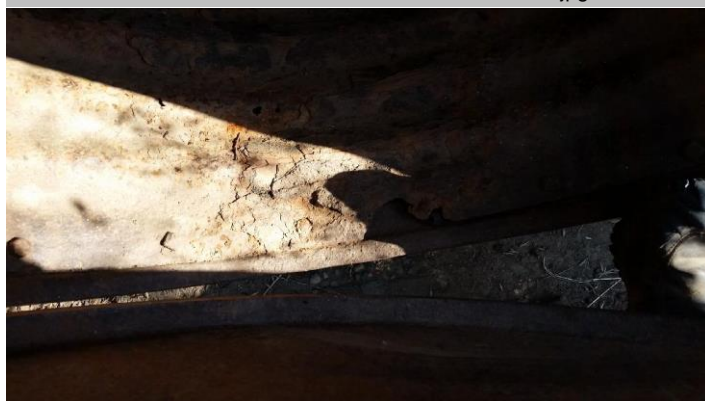
Photo 3 of 3 : UCIP_FA_2018_53136_75321.jpg

Deteriorated pipe wall at the outlet (WS).

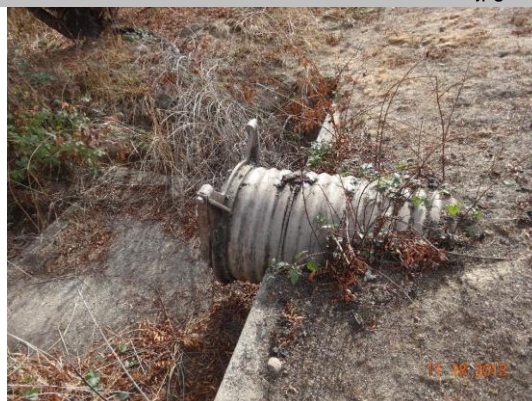
Photo 2 of 3 : UCIP_FA_2018_27745_51432.jpg

View of pipe, headwall, and flap gate located on waterward side.

Flap gate appears to be in good condition.

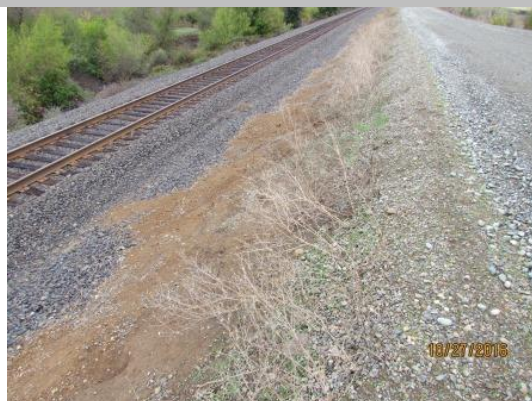
Photo 1 of 1 : FA_2018_RD0010_163_60_20180918_00023.jpg

View of squirrel holes on the landside slope and toe, no rodent activity was observed. Fall 2016.

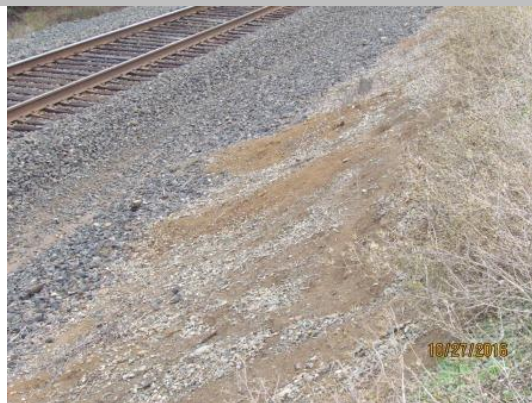
Photo 1 of 1 : FA_2018_RD0010_163_59_20180918_00022.jpg

View of squirrel holes on the landside slope and toe, no rodent activity was observed. Fall 2016.

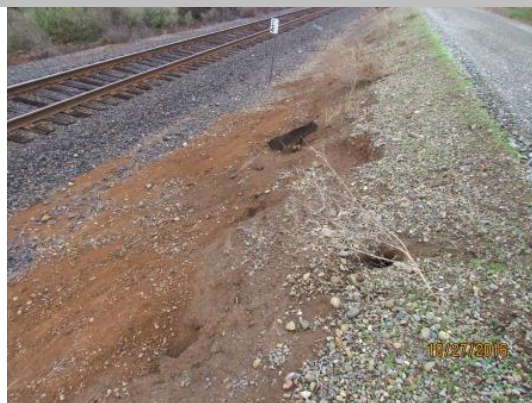
Photo 1 of 1 : FA_2018_RD0010_163_57_20180918_00020.jpg

View of squirrel holes on the landside slope and toe, no rodent activity was observed. Fall 2016.

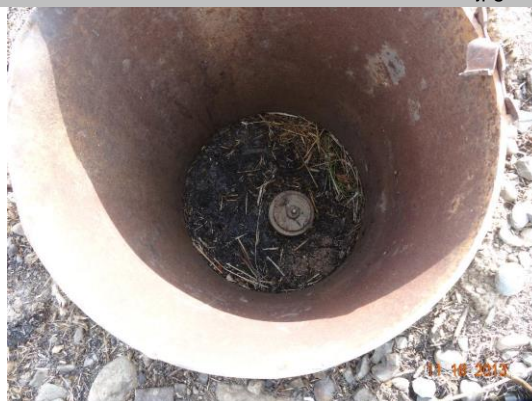
Photo 3 of 3 : UCIP_FA_2018_53137_44606.jpg

View of siphon breaker located inside steel riser.

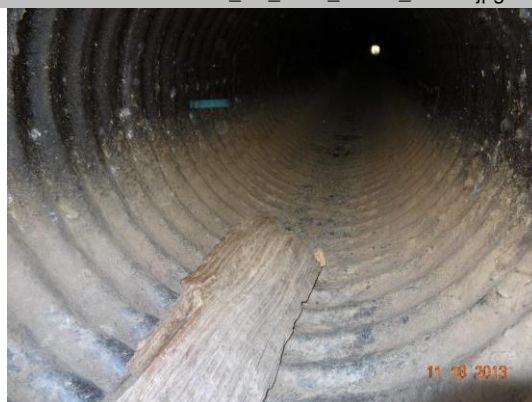
Photo 3 of 3 : UCIP_FA_2018_27747_51443.jpg

Internal view of pipe wall using camera with flash.

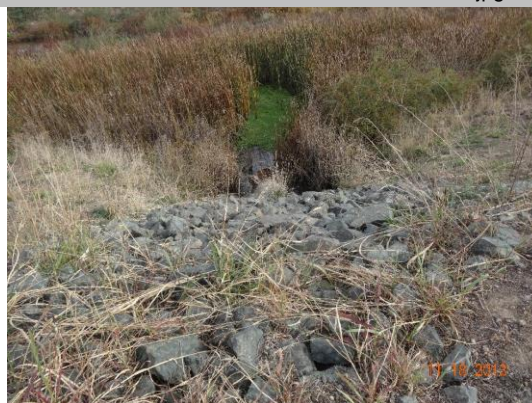
Photo 3 of 3 : UCIP_FA_2018_53138_44810.jpg

View of WS slope covered with rip rap along pipe alignment.

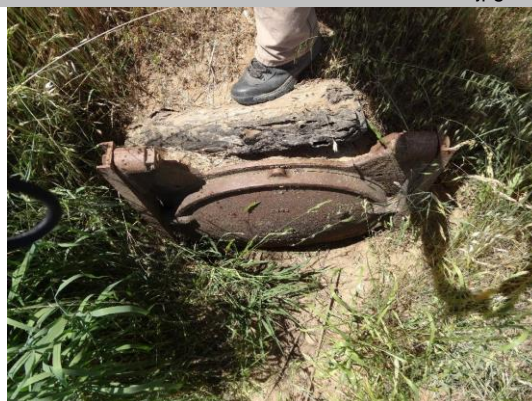
Photo 3 of 3 : UCIP_FA_2018_24438_43501.jpg

Pipe and flap gate confirmed on waterward side.

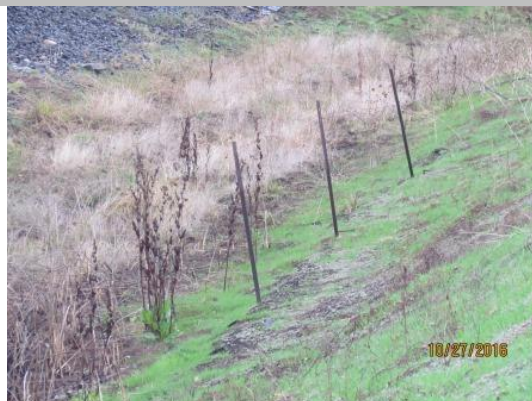
Photo 1 of 1 : FA_2018_RD0010_163_33_20180918_00003.jpg

View of fence post that run along the landside levee toe, looking upstream. Fall 2016.

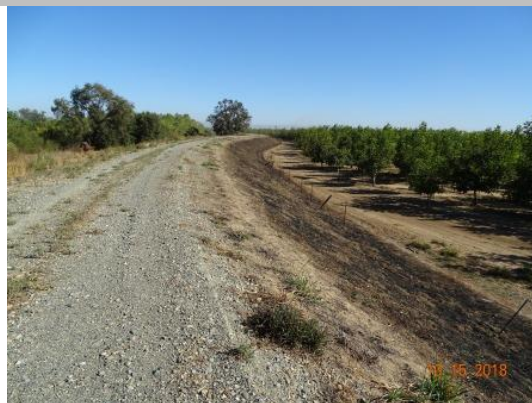
Photo 1 of 1 : FA_2018_RD0010_164_26_20181108_00093.jpg

View looking upstream landside of the well maintained vegetation, Fall 2018.

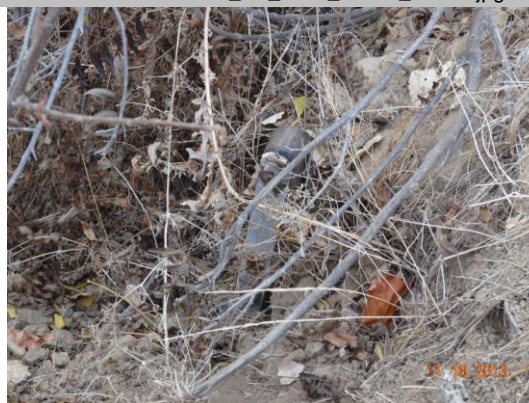
Photo 3 of 3 : UCIP_FA_2018_27533_51138.jpg

Buried flap gate on waterward side.

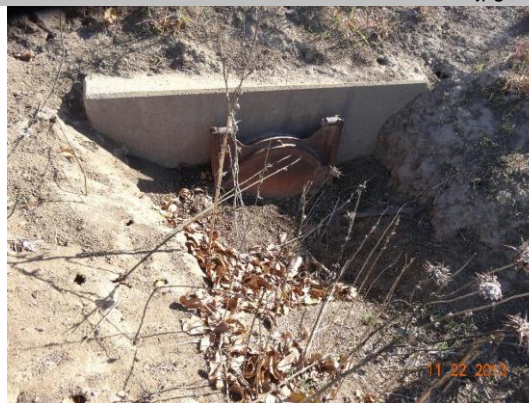
Photo 3 of 3 : UCIP_FA_2018_24825_44662.jpg

Flap gate located on waterward side--debris blocking gate.

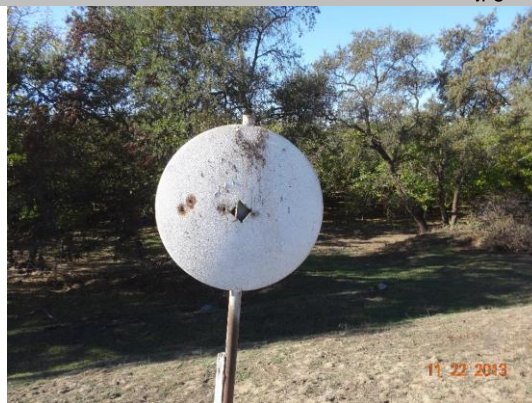
Photo 1 of 3 : UCIP_FA_2018_24826_44669.jpg

View of marker located on waterward shoulder, no reference number is visible.

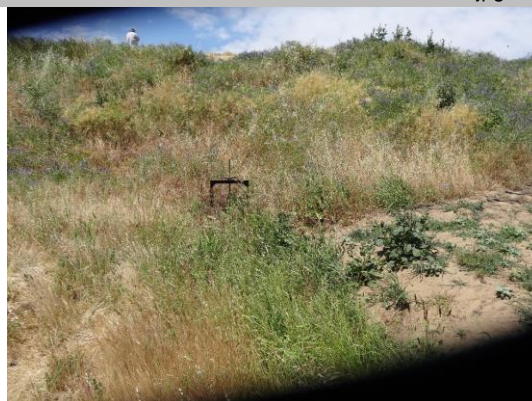
Photo 3 of 3 : UCIP_FA_2018_24751_44373.jpg

View of landward side--dense vegetation.

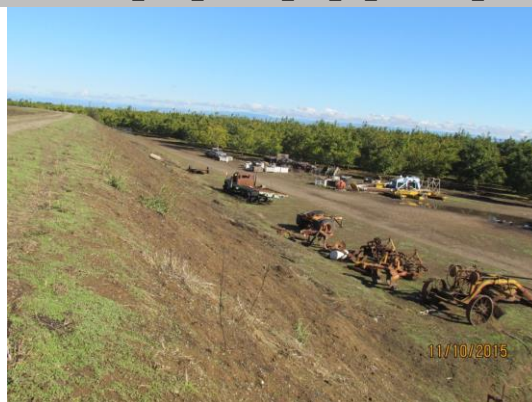
Photo 1 of 2 : FA_2018_RD0010_164_31_20180918_00006.jpg

View of the equipment at the toe of the levee on the landward side of the levee looking upstream. Fall 2015.

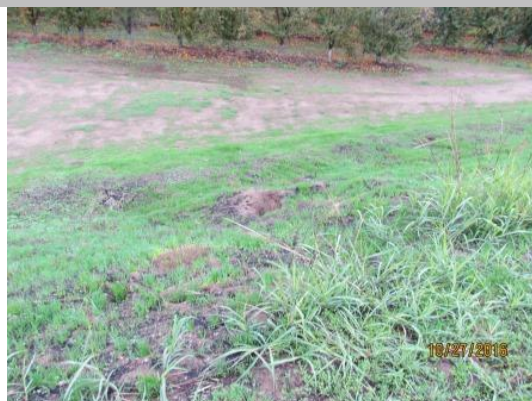
Photo 1 of 1 : FA_2018_RD0010_164_50_20180918_00020.jpg

View of rodent hole on landside slope. Fall 2016.

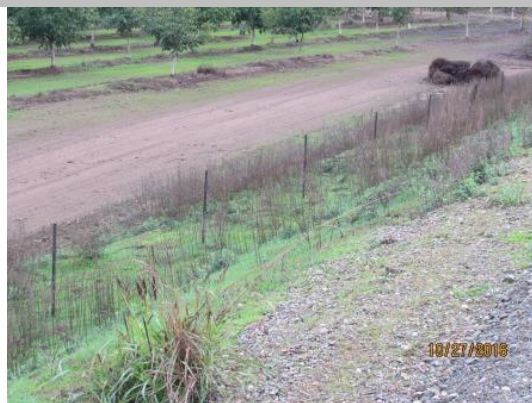
Photo 1 of 1 : FA_2018_RD0010_164_55_20180918_00022.jpg

View of fence at landside levee toe looking downstream.

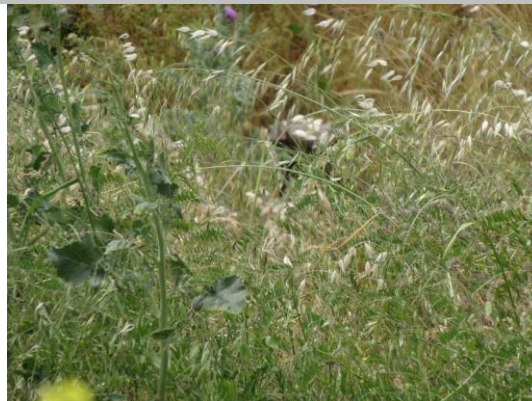
Photo 2 of 3 : UCIP_FA_2018_24768_44451.jpg

Dense vegetation on landward side.

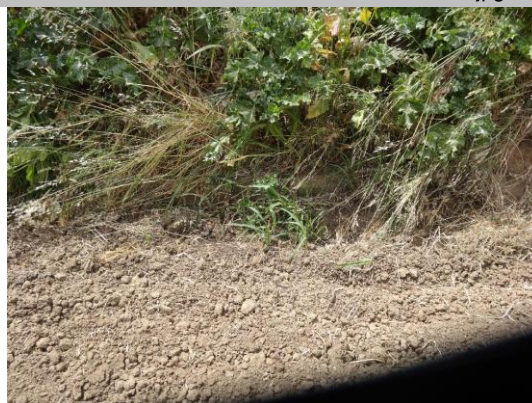
Photo 3 of 3 : UCIP_FA_2018_24768_44449.jpg

View of concrete headwall visible through dense vegetation.

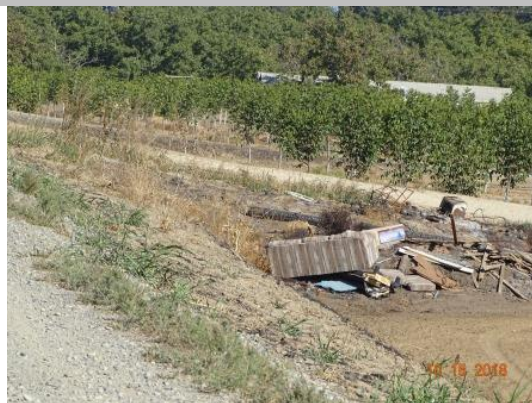
Photo 1 of 1 : FA_2018_RD0010_164_44_20181108_00097.jpg

View looking at the landside levee toe where debris has been dumped, Fall 2018.

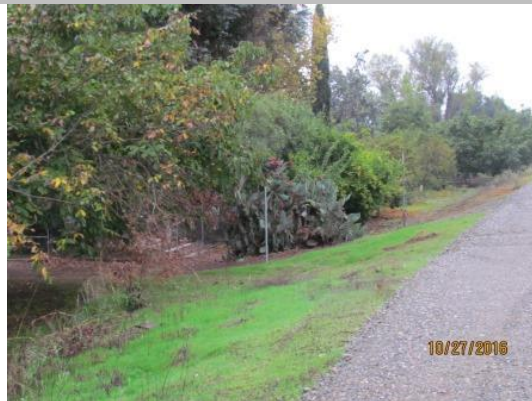
Photo 1 of 1 : FA_2018_RD0010_164_37_20180918_00013.jpg

View of the cactus on the landward side of the levee looking downstream.

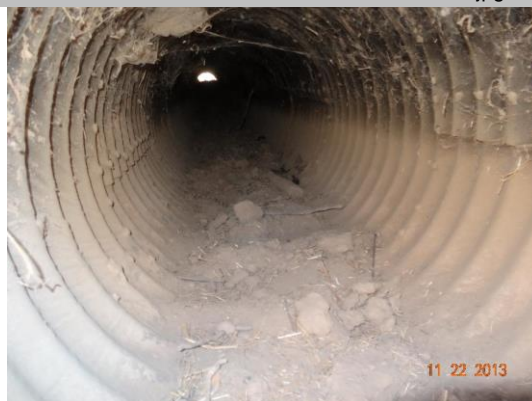
Photo 3 of 3 : UCIP_FA_2018_24840_44751.jpg

Internal view of pipe wall from waterward side.

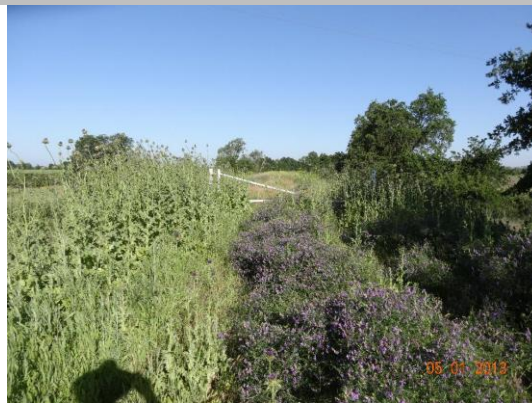
Photo 2 of 2 : UCIP_FA_2018_24883_44821.jpg

View of levee crown--dense vegetation.
